# Immediate placement of a Neoss ProActive® Edge implant in compromised bone.

Dr. Wim van Thoor, Germany

**Treatment plan:** Tooth extraction and immediate placement of a Neoss ProActive® Edge implant with simultaneous bone grafting using THE Graft (Purgo).

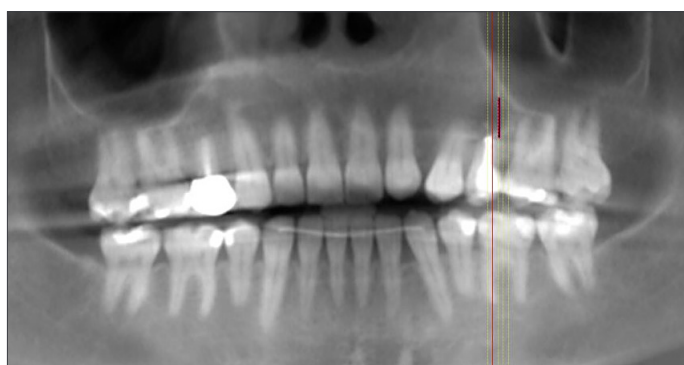
Figure 1.

The patient presented with a failing upper left first pre-molar. The CBCT shows the initial situation (Figure 1).

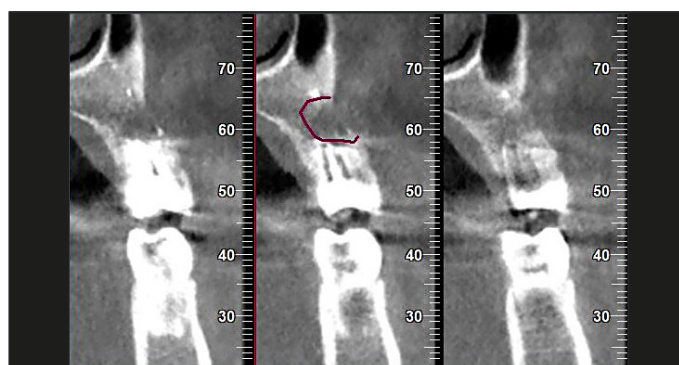
Figure 2.

Note what seems to be a big buccal fenestration in the area of the resected root (Figure 2).

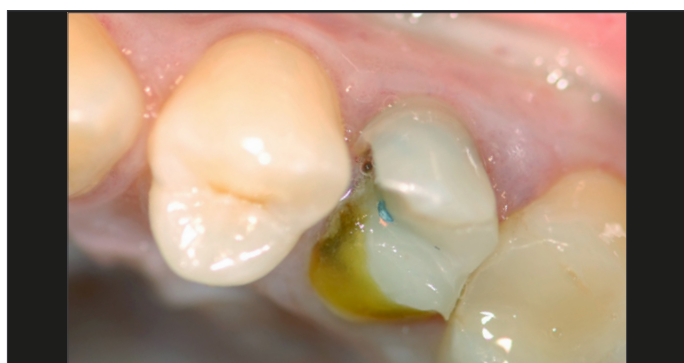
Figure 3.

The broken tooth was extracted (Figure 3 – 4).

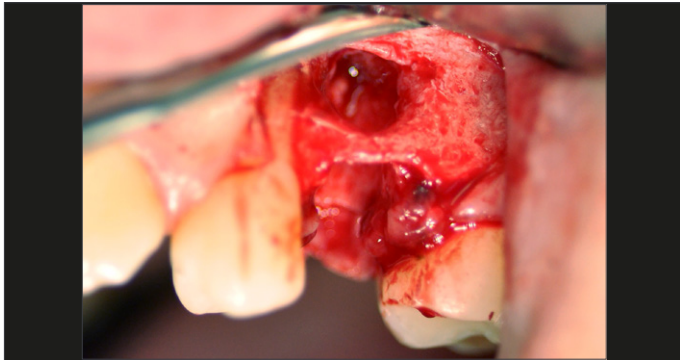
**Figure 5.**  
An access flap was lifted, revealing the buccal fenestration (Figure 5).

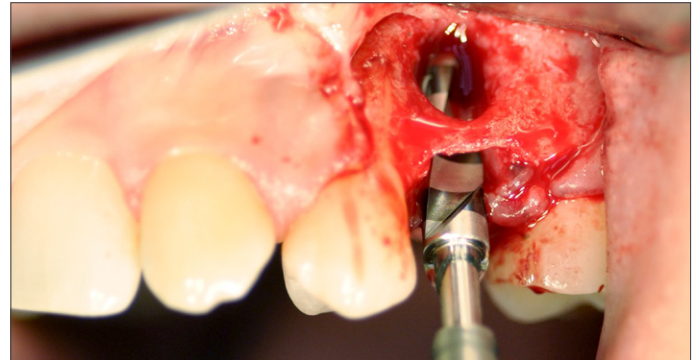
**Figure 6.**  
The osteotomy was prepared according to the Neoss ProActive® Edge drill protocol (Figure 6).

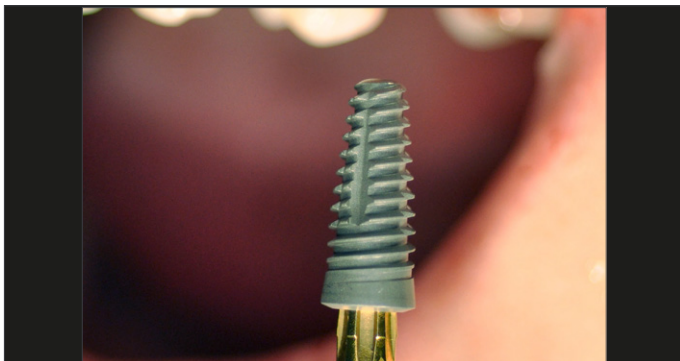
**Figure 7.**  
Placement of one Ø5.0 x 13 mm Neoss ProActive® Edge implant (Figure 7).

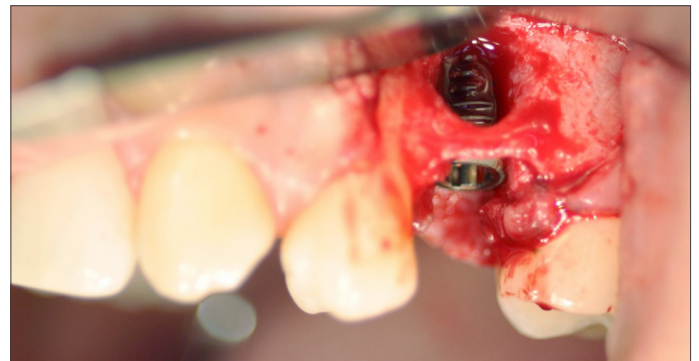
**Figure 8.**  
The implant was placed in very limited bone quantity of medium bone density (Figure 8).  
Good primary stability was reached despite the limited bone situation. The insertion torque was 20 Ncm and ISQ was 70/77.

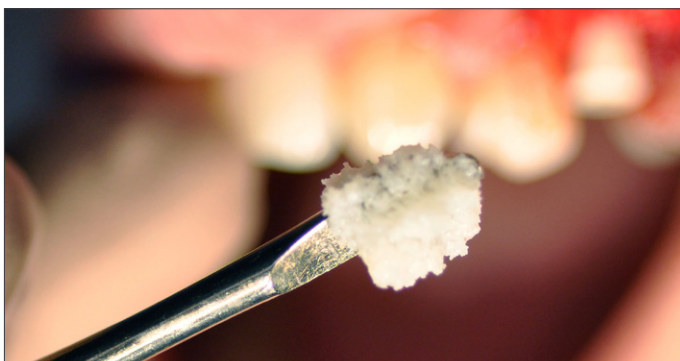
**Figure 9.**  
THE Graft (Purgo) cancellous bone granules (Figure 9) were used to correct the buccal fenestration (Figure 10).

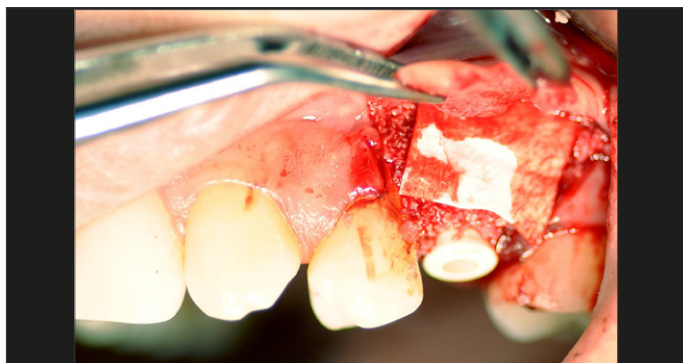
**Figure 11.**  
The bone graft was covered with a resorbable collagen membrane (Figure 11).

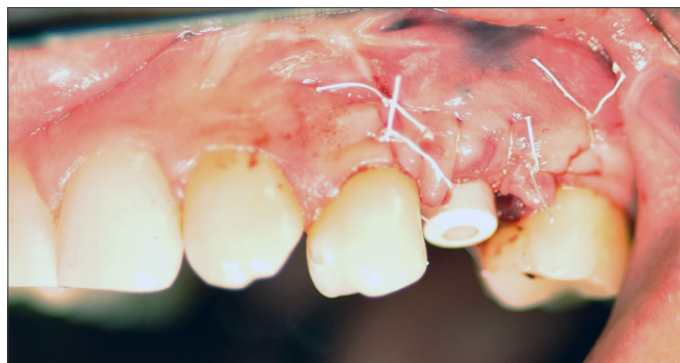
**Figure 12.**  
The mucosal flap was sutured around the PEEK healing abutment, allowing for one-stage healing (Figure 12).

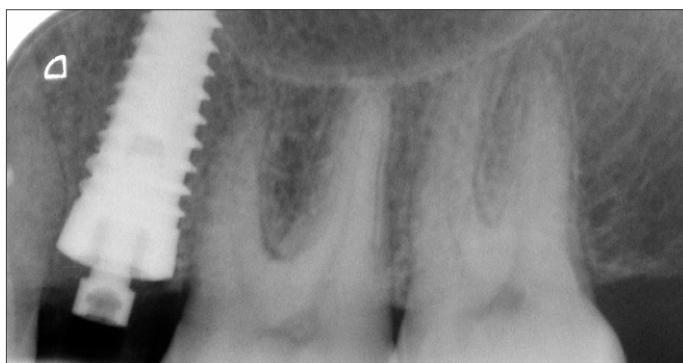
**Figure 13.**  
Radiograph showing the implant at time of insertion (Figure 13).

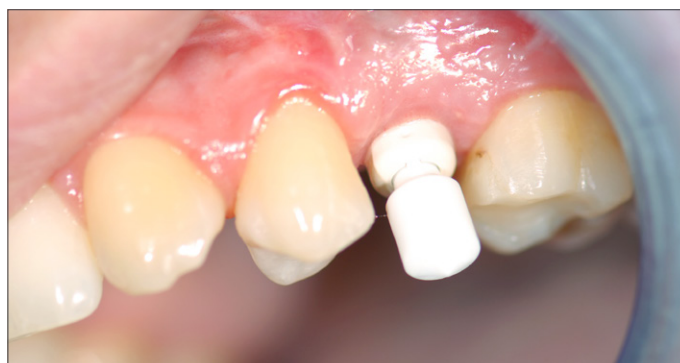
**Figure 14.**  
A Neoss ScanPeg was attached to the healing abutment (Figure 14), and the site was digitally scanned using an intraoral scanner (Figure 15).

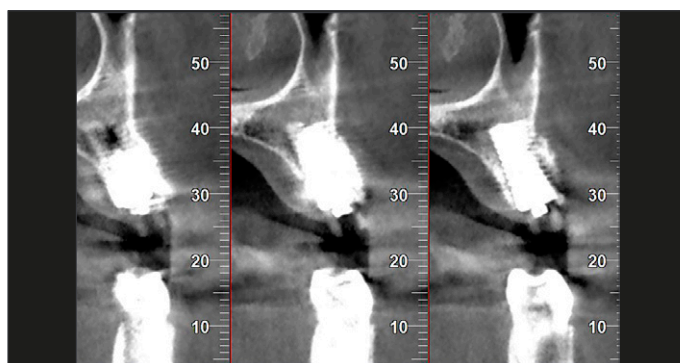
**Figure 16.**  
The CBCT after 3.5 months healing (Figure 16) shows good integration of the Edge implant and bone regeneration in the initial defect. The ISQ had increased to 72/79 further indicating good integration.

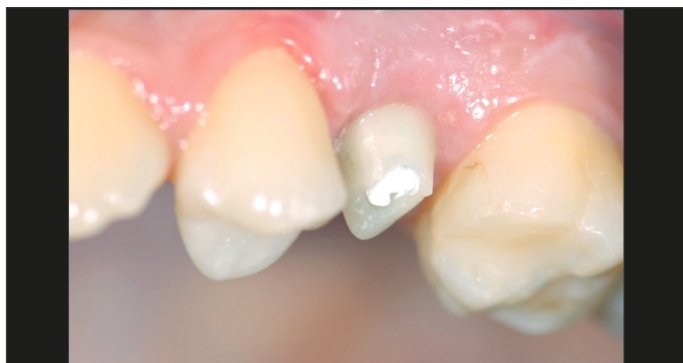
Figure 17.

Using a completely digital workflow, an individualized zirconia abutment was fabricated on a Neoss TiBase (Figure 17) and a zirconia crown was fitted on the abutment (Figure 18).
