Sinus elevation procedure using the Neoss ProActive Edge implant.

Dr. Wail Girgis, United Kingdom

Treatment plan: Sinus lift procedure and guided bone regeneration to allow simultaneous placement of a Neoss ProActive Edge implant for restoration of the missing molar.

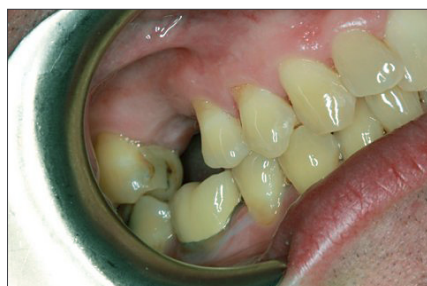
Figure 1

A female patient had the upper right first molar extracted due to tooth fracture. Buccal view after three months healing showed buccal resorption and stability of opposing dentition. (Figure 1).

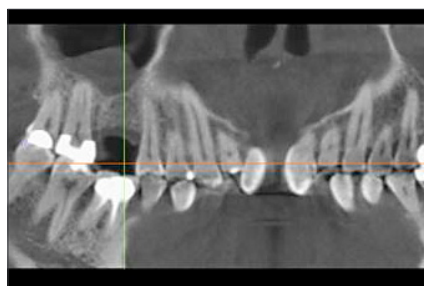
Figure 2

The pre-treatment CBCT showed limited vertical height of the residual sinus floor. It also showed inflammation of the sinus lining due to a cold. (Figure 2).

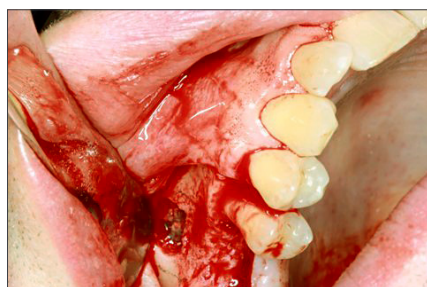
Figure 3

A buccal mucoperiosteal flap with a mesial relieving incision was performed. A lateral window was prepared using piezo surgery. The sinus membrane was elevated and kept intact (Figure 3).

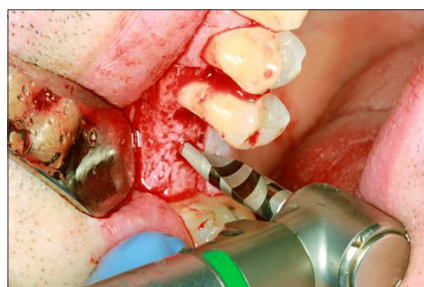
Figure 4

The osteotomy was prepared according to Neoss ProActive Edge drill protocol (Figure 4) using a countersink to finish the coronal osteotomy preparation (Figure 5).

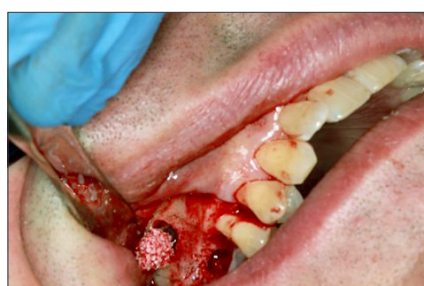
Figure 6

Xenograft material was placed in the lateral window and pushed to the palatal wall to help maintain the elevated sinus membrane (Figure 6).

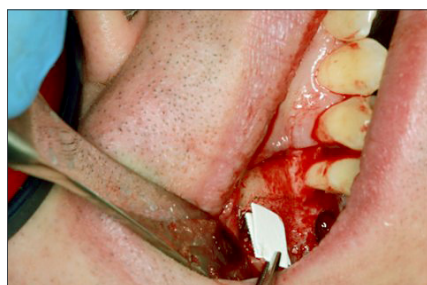
Figure 7

A resorbable collagen membrane was placed on the sinus membrane floor (Figure 7).

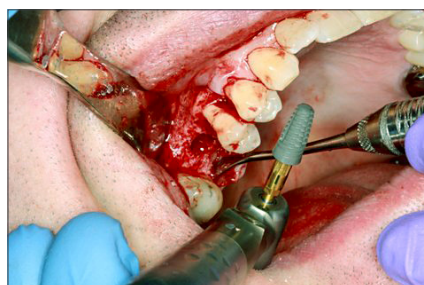
Figure 8

Placement of a Neoss ProActive Edge Ø5.0 × 11 mm implant (Figure 8-9). A final insertion torque of 25 Ncm was reached despite limited bone situation.

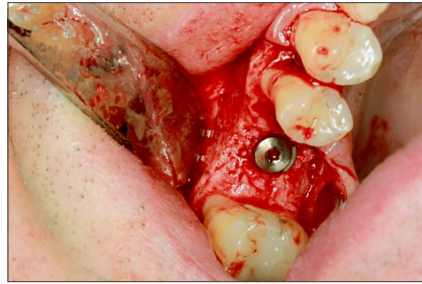
Figure 10

Placement of cover screw (Figure 10).

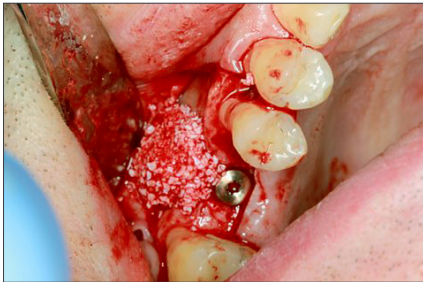
Figure 11

Further xenograft material was placed to fill the lateral window as well as to build out the bony architecture buccally (Figure 11), and a double layer of collagen membrane was placed over the graft (Figure 12).

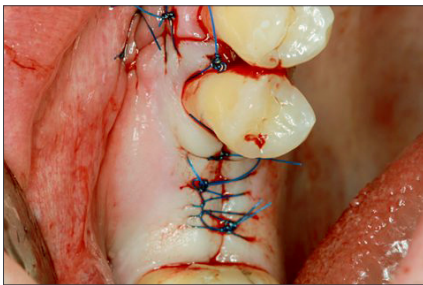
Figure 13

Soft tissue closure with multiple non-resorbable sutures (Figure 13).

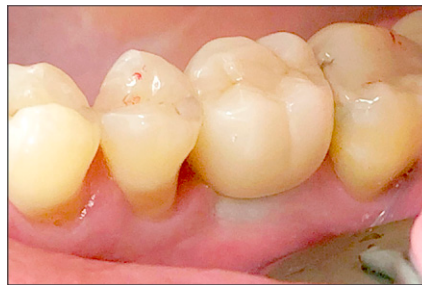
Figure 14

Ten months after implant placement, permanent prosthetic delivery (Figure 14) with stable bone levels (Figure 15).
