## Neoss ScanPeg – simplified intra-oral scanning

A 4.0×11 mm Neoss ProActive® Tapered implant was placed in the lower first molar position following 3D radiological examination. A minimal flap was raised to split the small amount of keratinized soft tissue. Excellent primary stability was obtained, insertion torque >50 Ncm and 76 ISQ.

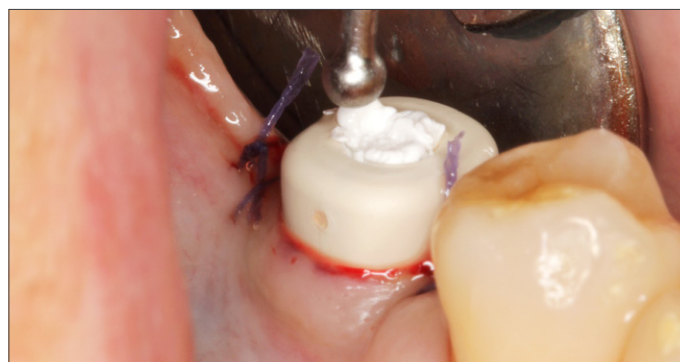
Figure 2.

Note the buccal orientation of the groove, which functions as a direction feature, to ensure proper anatomical transgingival shape. The screw channel was filled with PTFE material (Figure 2).

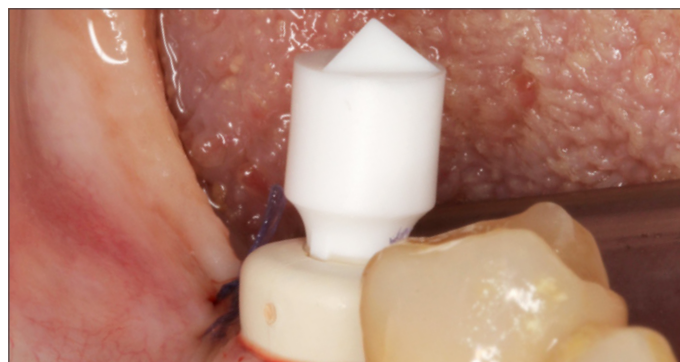
Figure 3.

At time of scanning, the PTFE material was removed, the push-in ScanPeg was seated inside the Healing Abutment (Figure 3 & 4), and an intra-oral scan was taken.

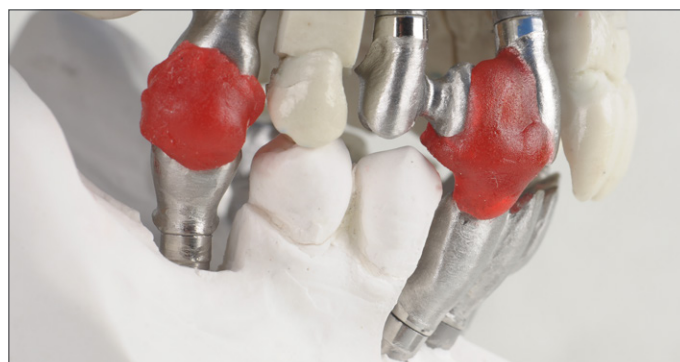
Figure 6.

Since there was no need for a temporary crown for esthetic reasons, and the soft tissue was conditioned by the healing abutment, it was decided to immediately produce the definitive restoration. A CAD crown was designed by the laboratory with a minor correction of axis (12°). A library of preset transgingival shapes in the CAD library that matched the shape of the healing abutment simplified the design work. A Cobalt Chromium restoration was milled (Arc Solutions, Helsingborg, Sweden). The milled abutment was mounted in the stone model and occlusion was tested before layering the framework with porcelain (Figure 6).

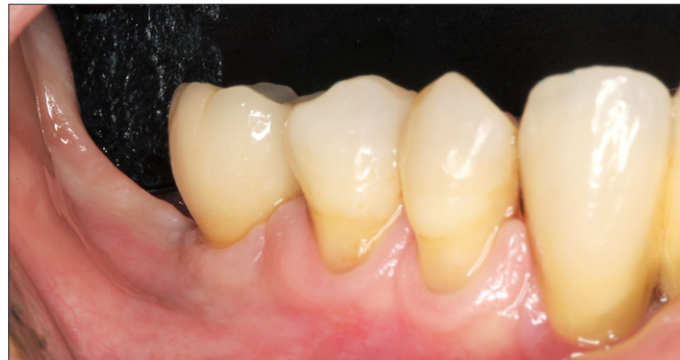
Figure 8.

Final restoration with matching transgingival shape in place (Figure 8).
