Vertical ridge augmentation with titanium-reinforced PTFE Membrane

Vertical and horizontal guided
bone regeneration of a severely
resorbed mandible with a
titanium-reinforced PTFE membrane

Isabella Rocchietta, DDS, MSc
Specialist in periodontics
Milan, Italy

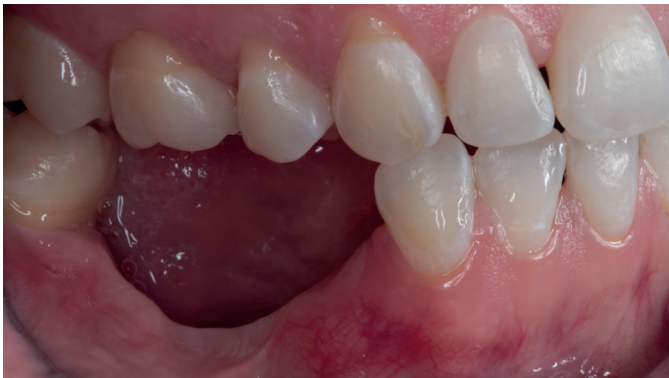
Figure 1. Initial clinical situation. Severely resorbed posterior mandible following a previous failed attempt to insert dental implants with a split-crest technique.

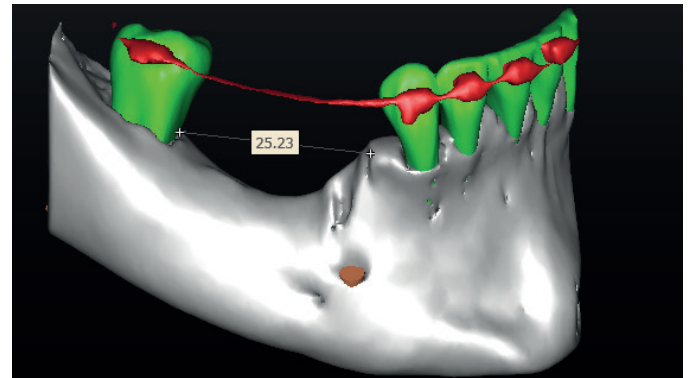
Figure 2. CBCT evaluation showing a major bone defect in the posterior area of the mandible, with a length of 25 mm and a height of about 10 mm.

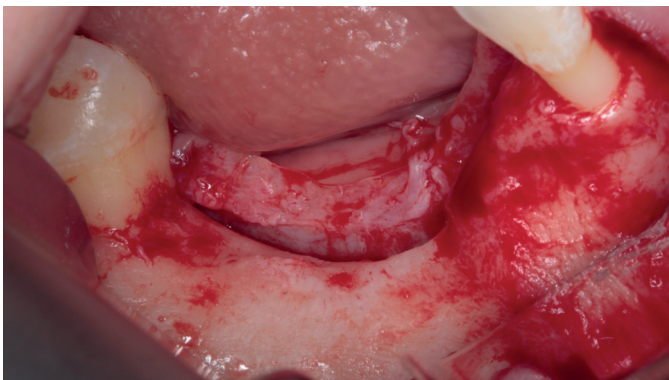
Figure 3. Bone defect visible after full thickness flap elevation. A mid-crestal incision was performed with intrasulcular incisions. Vertical incisions were performed one tooth away from the defect.

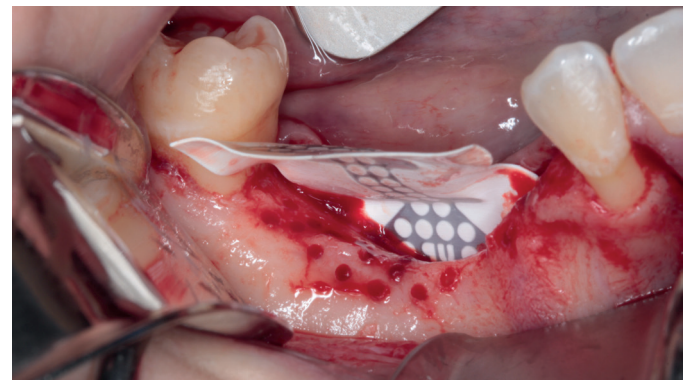
Figure 4. The site was prepared with bone perforation. A NeoGen Ti-Reinforced PTFE Membrane was inserted and fixed lingually with two screws. The titanium-reinforced membrane provides structural support for space maintenance and undisturbed bone regeneration.

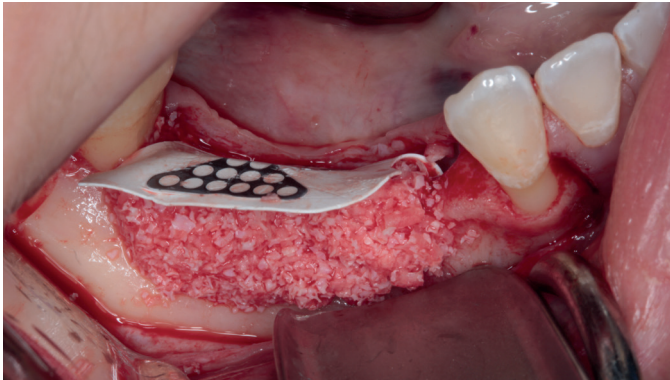
Figure 5. Bone augmentation. Positioning of bone graft (50% autologous bone and 50% deproteinized xenograft) to support site augmentation.

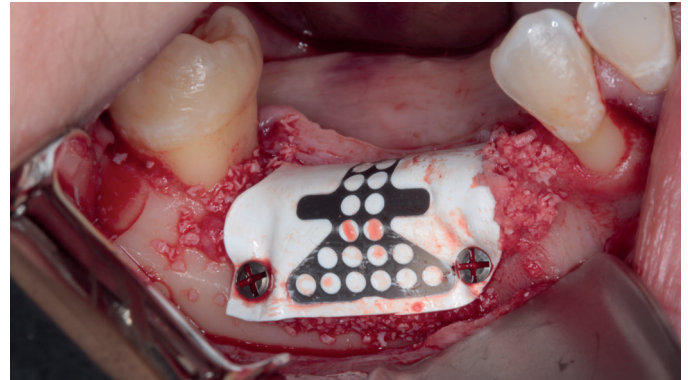
Figure 6. The membrane is fixed buccally with two screws under tension to ensure good stability of the augmentation site.

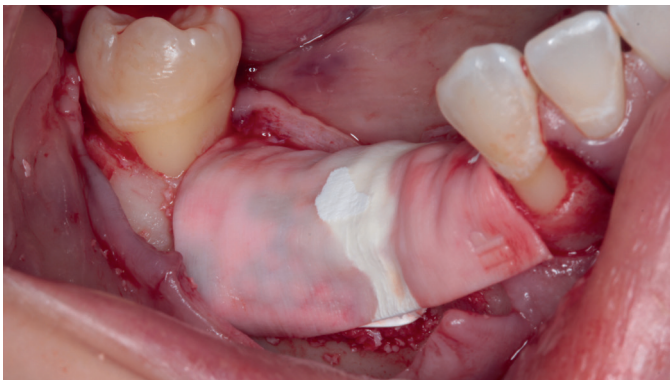
Figure 7. Full coverage of bone graft particulates. A collagen membrane was used to cover the bone particulate close to the adjacent teeth that were not covered by the PTFE membrane.

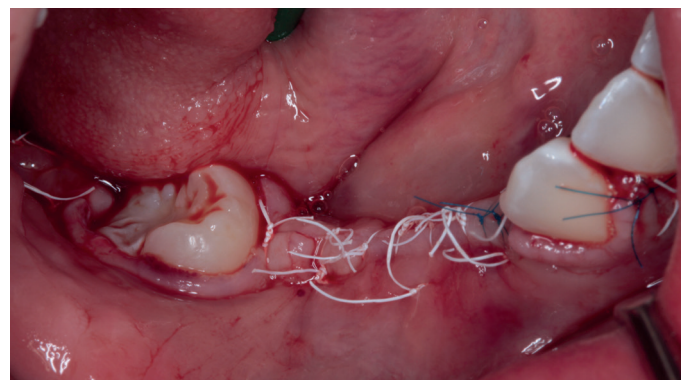
Figure 8. Tension-free primary closure. Periosteal flap releasing incisions in order to achieve a tension-free and complete primary closure of the site.

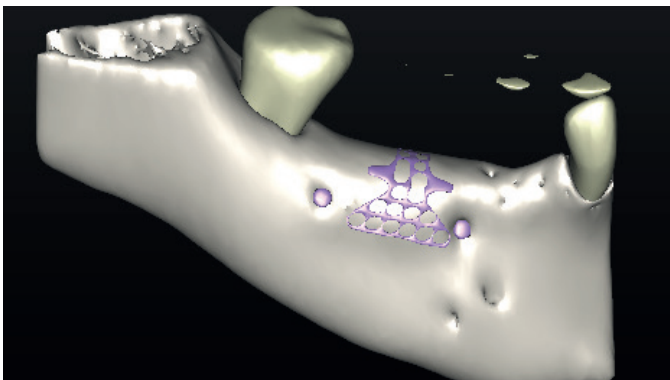
Figure 9. CBCT after nine months of healing. Note the level of regenerated bone up to the NeoGen Ti-Reinforced PTFE Membrane.

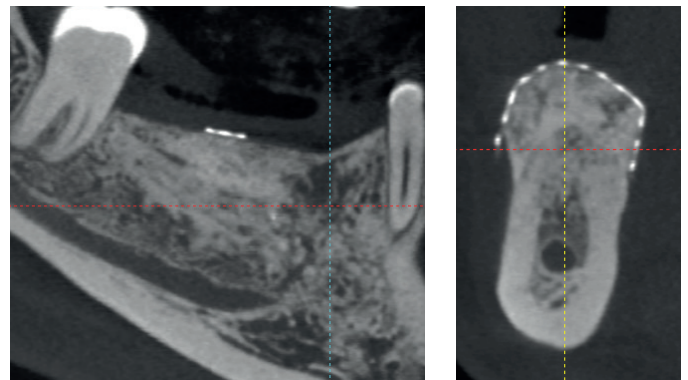
Figure 10. CBCT evaluation after nine months of healing, note the vertical and horizontal bone regeneration, filling the whole volume under the NeoGen Ti-Reinforced PTFE Membrane.

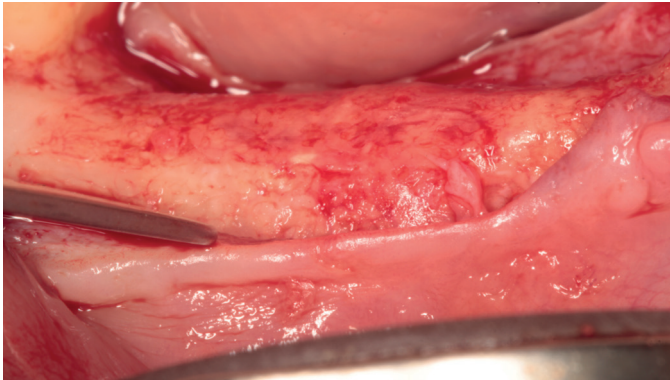
Figure 11. Re-entry nine months after augmentation, after removal of the membrane. Note the level and width of regenerated bone. The newly formed bone is highly vascularized as indicated by abundant bleeding during site preparation for implant placement.

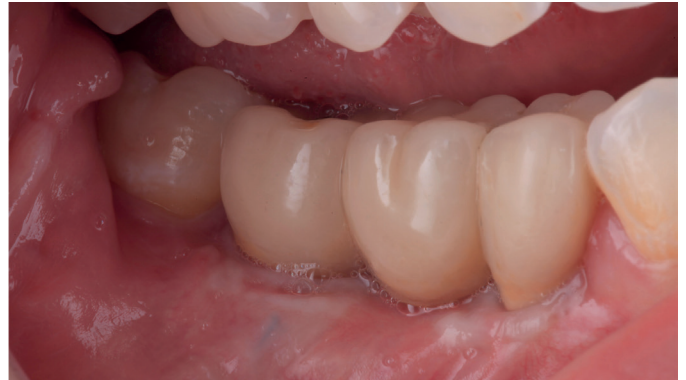
Figure 12. Final restoration delivered six months after implant placement. The tissue levels are stable around the restoration with a satisfactory esthetic result.

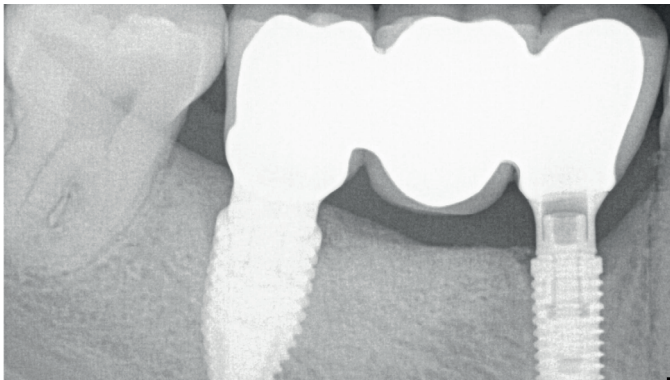
Figure 13. Radiograph six months after implant placement with final restoration. The bone level is stable at implant level.
