Long-term clinical success and stable bone levels with the Neoss Implant System

Dr. Thomas Zumstein, Switzerland

Case Report

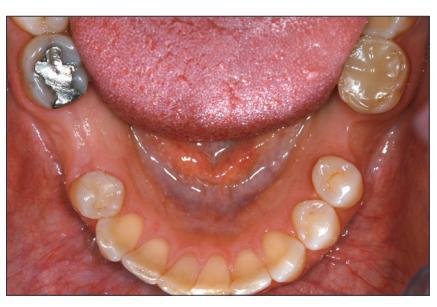
Figure 1

A healthy patient with good oral hygiene presented with two bilateral missing teeth in the first molar area of the mandible. The right molar area having a large gap giving the choice of placing one or two implants in this area (Figure 1).

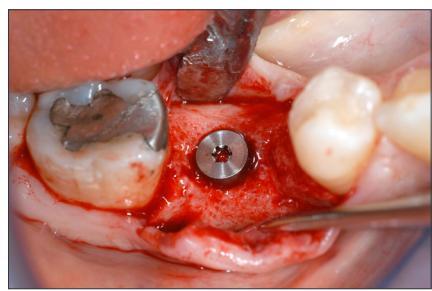
Figure 3

A total of two Neoss implants (4.0×11 mm) were placed in a slight supracrestal position in the right and left molar area respectively. For the right first molar area a distal implant position for a single implant placement was chosen, ensuring correct position and direction during drilling with a direction gauge (Figure 2) to allow for a mesial cantilever. It is crucial to achieve good primary stability and correct position and direction of the implant to allow for controlled loads. A cover screw was placed and the implants were left submerged during the 12-week healing period (Figure 3).

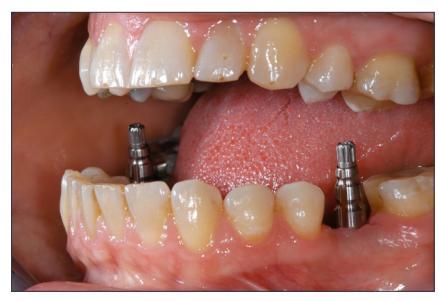
Figure 5

After reopening, PEEK healing abutments were connected and soft tissue was allowed to heal for an additional 2 weeks before impression taking (Figure 4). Impression copings were attached allowing for an open impression tray modified with access holes that matched the implant positions (Figure 5 and 6).

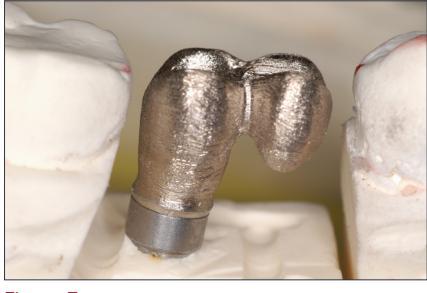
Figure 7

The lab created cast, wax up frameworks in gold (Figure 7) on NeoLink abutments. The cantilever was placed mesially since bite forces are lower on the mesial side than on the distal side. The tooth mesial to the cantilever is crucial for sensory feedback to not overload the cantilever. The final crowns were gold ceramic screw retained single crowns (Figure 8). Tight contact between the crowns and adjacent teeth both mesially and distally was ensured to avoid problems with food impaction.

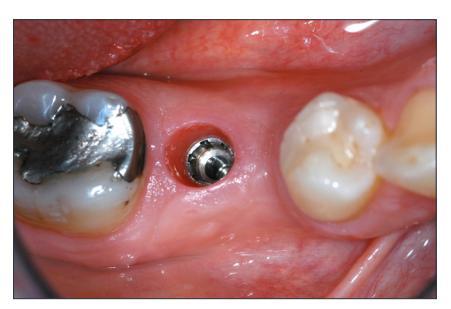
Figure 9

At time of prosthetic delivery the PEEK healing abutments were disconnected and healthy soft tissue around the implant was revealed (Figure 9).

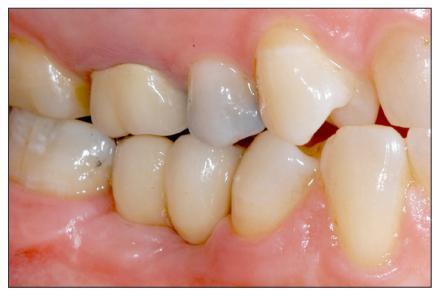
Figure 11

The definitive prostheses were tried (Figure 10 and 11). Articulating foil was used to avoid direct occlusal contacts. The screw access holes were closed after try-in and delivery.

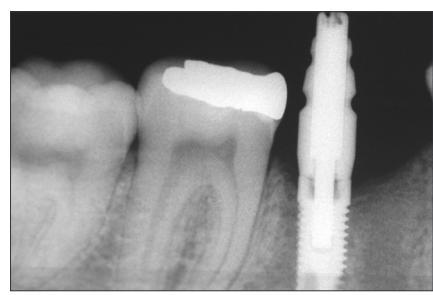
Figure 13

Bone levels also remained stable over the entire 14 years as shown by the radiographic baseline (Figure 13 and 14) and 14 year follow-up (Figure 15 and 16). Thus, this case shows that with the Neoss implant system, stable long-term bone and soft tissue levels can be achieved.
